Mines Safety Bulletin No. 98

Subject: Serious crush injuries from pedal-controlled skid steer equipment

Date: 23 March 2012

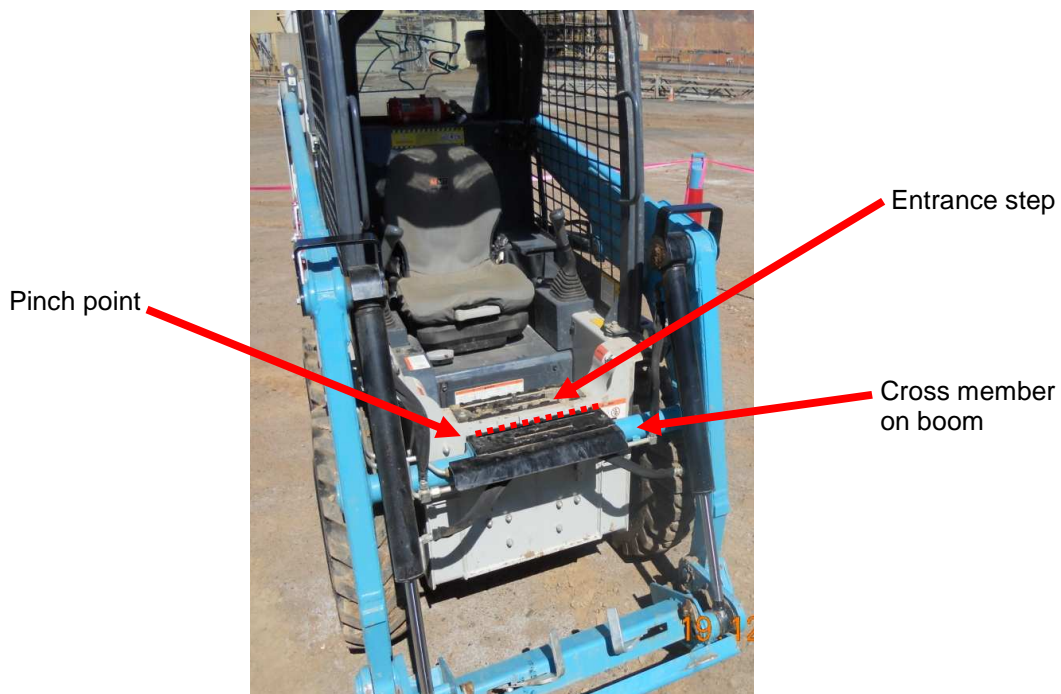
In both incidents, the operator had stretched his right leg over the entrance step in front to relieve cramping. The resulting shift in weight had transferred pressure to the left foot, activating the boom control pedal and causing the boom to descend. The operator's right leg had been crushed between the entrance step and a cross member on the boom.

Example of skid steer involved in both incidents showing line of pinch point between entrance step and cross member on boom.

- The confined cabin space can restrict operator movement, leading to leg cramps.
- There is no physical barrier to prevent the extension of a limb into the area of the pinch point.
- Foot pedal controls can be inadvertently activated by a shift in the operator's weight.

Under regulation 4.4(3) of the Mines Safety and Inspection Regulations 1995, employers are required to "ensure that any moving machinery that creates a risk of injury to an employee through inadvertent contact is screened or guarded to prevent such contact." For skid steer equipment with confined cabin space and a pinch point hazard, this may be achieved by:

- installing a cabin door (e.g. meshed or fully enclosed tempered glass with a stone guard) that is interlocked to the operation of the machine
- ensuring doors, if provided by the supplier, are not removed when the unit is placed into service
- supervisors encouraging operators to take regular breaks and stretch.
