CMEIG Engineering Position Paper

Chain Shot Phenomenon

Engineering Position Paper No.4 – Amended 18 September 2008

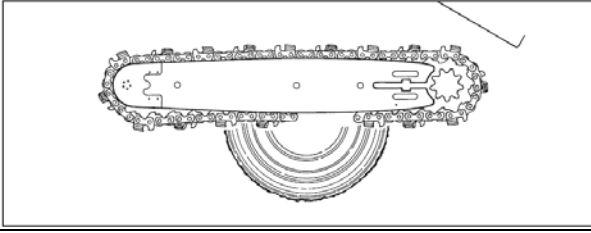
The free end of the chain begins to whip away from the break.

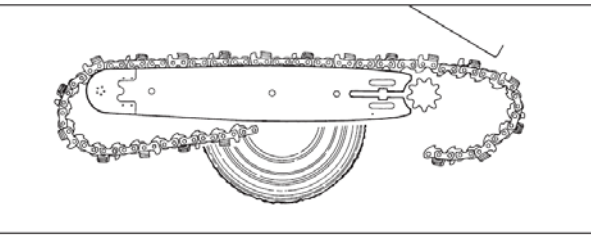
If the chain is not contained by the saw box or an energy-absorbing guard, the broken chain's free end can speed up rapidly and carry immense dynamic energy.

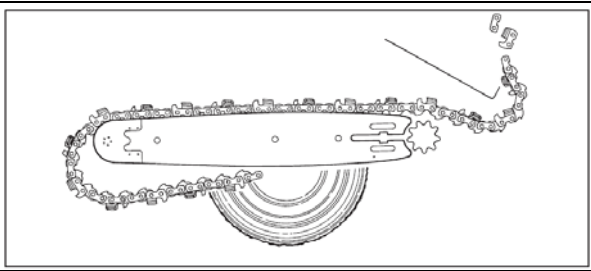
At the peak of the whip, chain parts may break loose and be ejected at high speed, especially if the free end of the chain strikes the saw box. Chain shot can cause chain parts to be thrown in many directions, especially along the plane of the saw bar.	Fragments have been measured at between 180 and 310 m/s under laboratory simulated conditions.

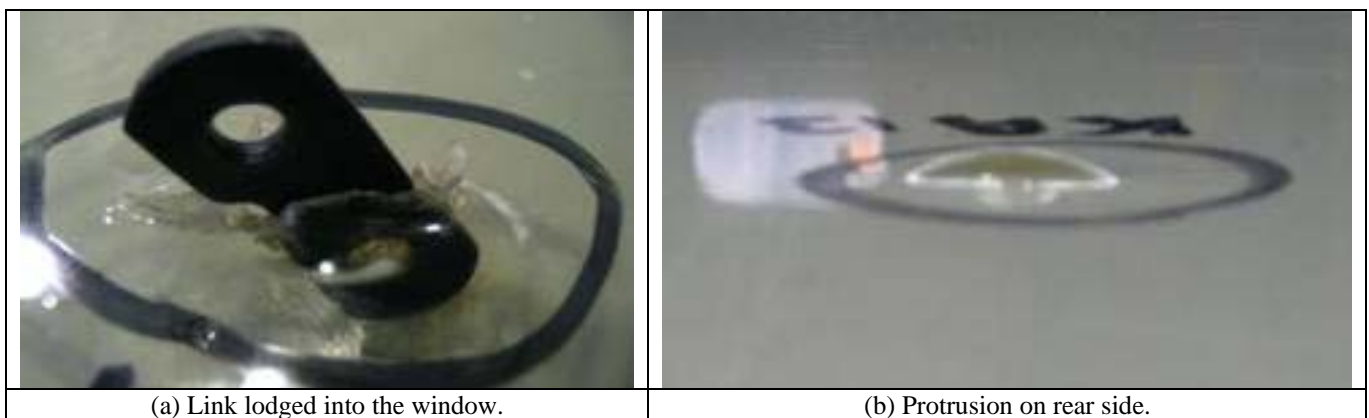
Type	No. of tests	Observations
1	10	Projectiles were able to penetrate the material and cause a 5mm deformation on the rear surface on the window. Refer to Figure 3.
2	7	Projectiles were able to penetrate the outer polycarbonate layer, but were contained by the acrylic layer. The rear layer of polycarbonate was not penetrated, however it was partially delaminated. Refer to Figure 4.
3	9	Projectiles were able to penetrate the material to a maximum depth of 18 mm. Refer to Figure 5.

Figure 3 Photos from type 1 test (refer to Tables 2 and 3 for more details).

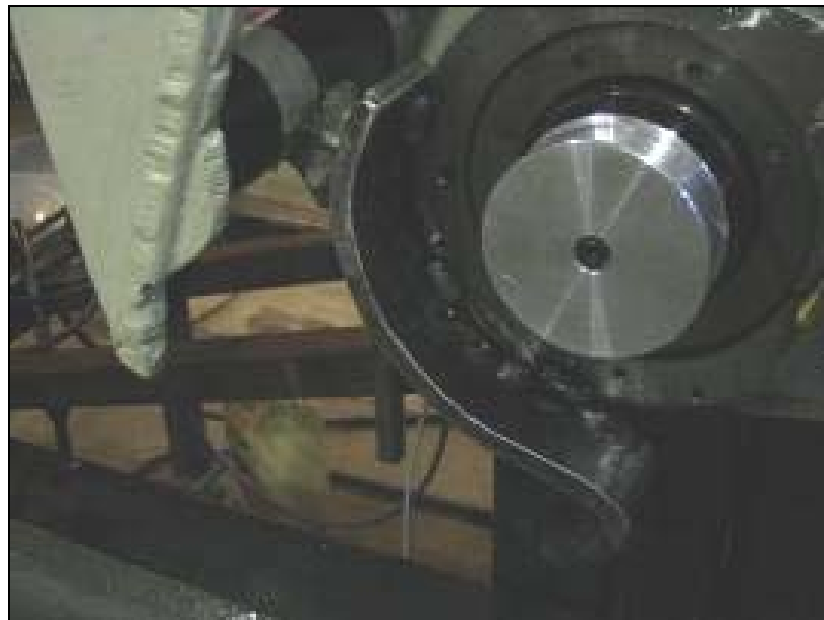
The chain arrestor was designed by KAL in conjunction with SMP and Komatsu Forest R & D team. Figure 6 shows the prototype device fitted to the test rig. The chain arrestor works by collecting the chain in the event of breakage and preventing the whip lash effect that can cause chain shot.

Figure 6 The proposed K-saw chain arrestor.

In the 22 tests that were carried out with the chain arrestor fitted there were no instances in which chain shot occurred.

- Fit the Lexgard MP750 19 mm Polycarbonate Acrylic Laminate or the Lexgard SP-1250 32 mm polycarbonate laminate to the front windows of all machines (in the case of machines requiring impact resistance and where steel bars are not fitted, then SP-1250 should be fitted)
- Fit the chain arrestor
- Review the speed and maximum pressure of the saw to ensure they are within specification.
- Fit tamper indicators to the adjustments for the pressure and flow control valves.
- Extend the exclusion zone extension at least 50 m line of site through the front window.
- Update operator and other technical documentation to reflect best practice changes.

The chain arrestor prevented chain shot from occurring in 100% of the tests and is a better design solution than a screen alone.
