## CMEIG Engineering Position Paper

### Chain Shot Phenomenon

Engineering Position Paper No.4 – Amended 18 September 2008

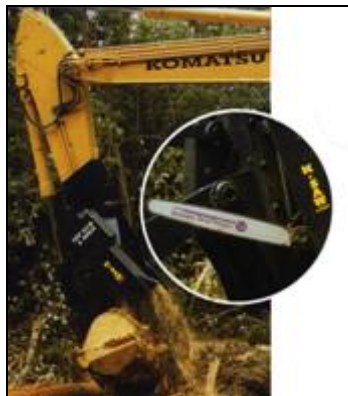
The K-Saw is a hydraulically powered chain saw used in conjunction with a log grab to trim felled trees to length (see Figure 1). The K-Saw has been fitted to various manufacturers' hydraulic excavators.

**Figure 1** The K-saw commonly attached to a hydraulic excavator.

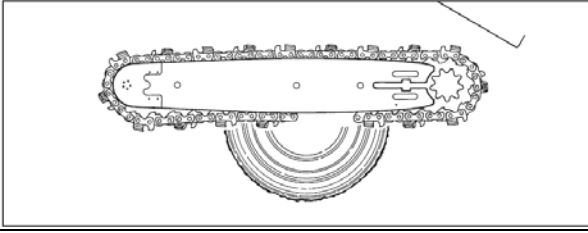
Sequence of events	Diagrammatic representation
After a chain break .....

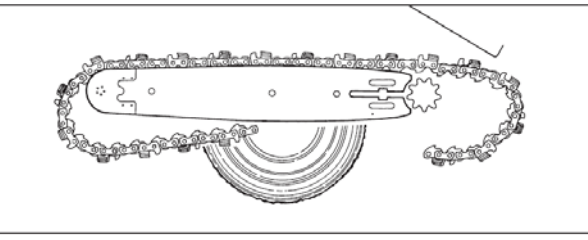
The free end of the chain begins to whip away from the break.

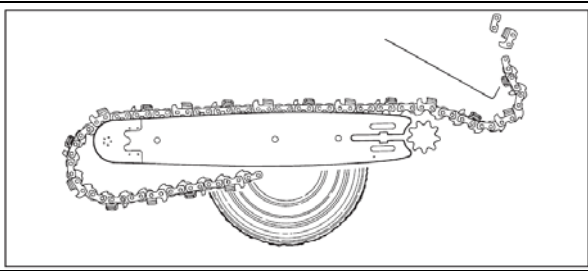
If the chain is not contained by the saw box or an energy-absorbing guard, the broken chain's free end can speed up rapidly and carry immense dynamic energy.

At the peak of the whip, chain parts may break loose and be ejected at high speed, especially if the free end of the chain strikes the saw box. Chain shot can cause chain parts to be thrown in many directions, especially along the plane of the saw bar.	Fragments have been measured at between 180 and 310 m/s under laboratory simulated conditions.

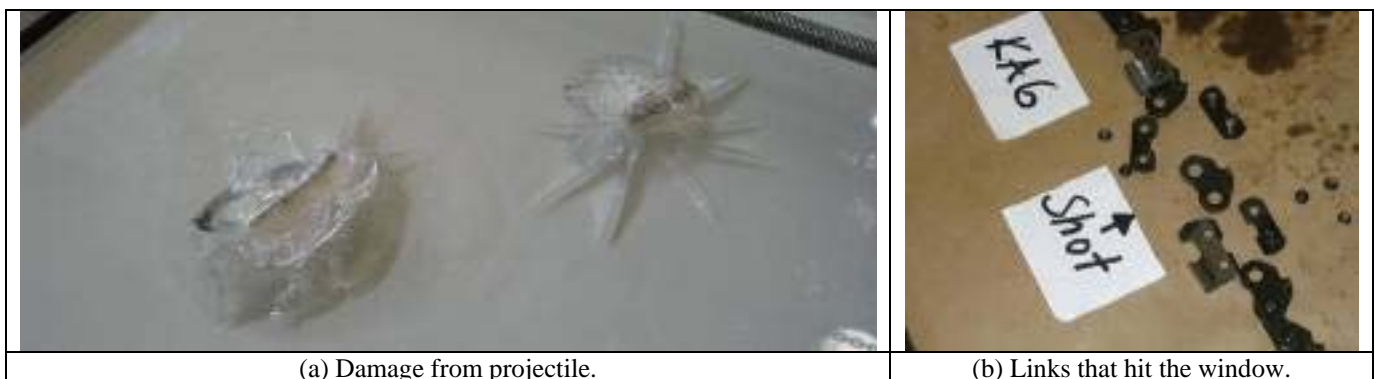
**Figure 4** Photos from type 2 test (refer to Tables 2 and 3 for more details).

Type	No. of tests	Observations
1	10	Projectiles were able to penetrate the material and cause a 5mm deformation on the rear surface on the window. Refer to Figure 3.
2	7	Projectiles were able to penetrate the outer polycarbonate layer, but were contained by the acrylic layer. The rear layer of polycarbonate was not penetrated, however it was partially delaminated. Refer to Figure 4.
3	9	Projectiles were able to penetrate the material to a maximum depth of 18 mm. Refer to Figure 5.

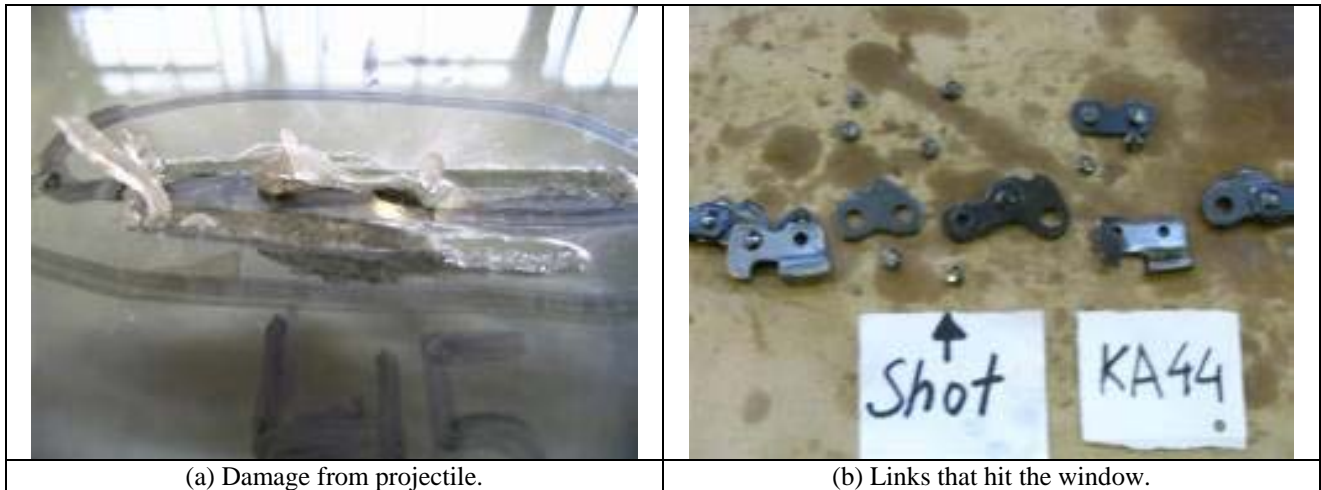
**Figure 5** Photos from type 3 test (refer to Tables 2 and 3 for more details).

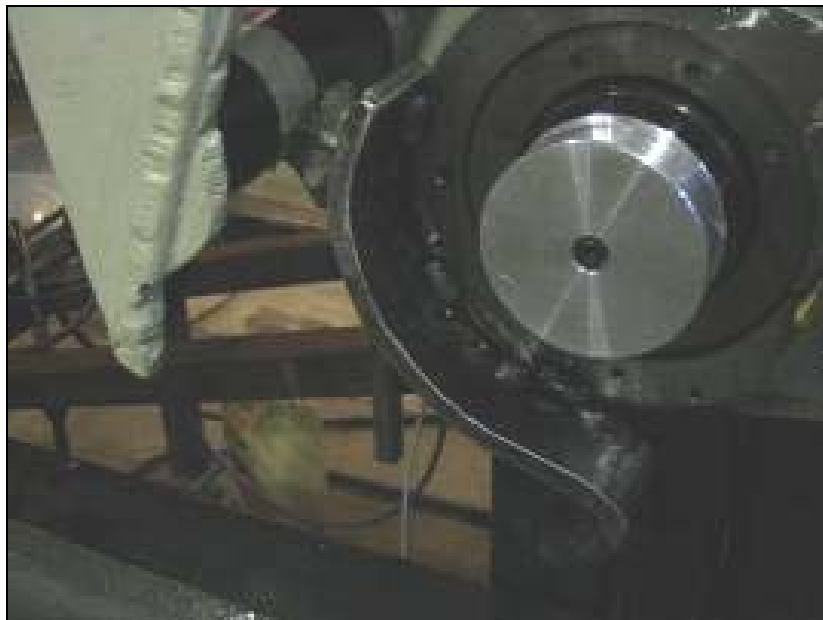
The chain arrestor was designed by KAL in conjunction with SMP and Komatsu Forest R & D team. Figure 6 shows the prototype device fitted to the test rig. The chain arrestor works by collecting the chain in the event of breakage and preventing the whip lash effect that can cause chain shot.

**Figure 6** The proposed K-saw chain arrestor.

In the 22 tests that were carried out with the chain arrestor fitted there were no instances in which chain shot occurred.

The chain arrestor prevented chain shot from occurring in 100% of the tests and is a better design solution than a screen alone.
